**Flood Control Project Maintenance
Levee Inspections**
LMA District Cover Sheet
Spring 2017 Levee Inspection Results

American River Flood Control District

Spring 2017 Levee Inspection Results

Waterway			Bank	Unit Miles
Unit No. 01 Arcade Creek			Left	2.08
	Spring (March - May)	Summer (June - August)	(September - November) Fall	Winter (December - February)
Unit Maintenance Rating (Fall Only)				
Date of Inspection	3/15/2017 - 5/3/2017			
DWR Inspector	Maksim Khashchuk			
Accompanied By	Ross Kawamura ARFCD

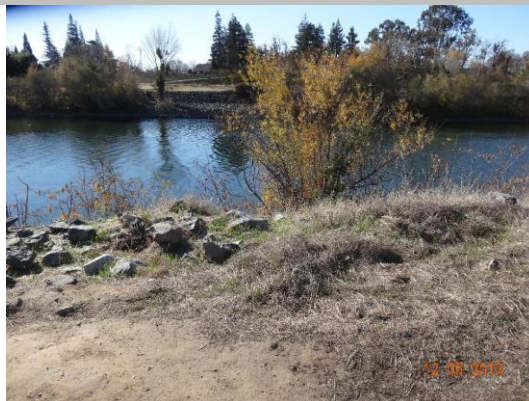
Photo 2 of 3 : UCIP_SP_2017_30124_55521.jpg

Rip rap used along waterward toe.

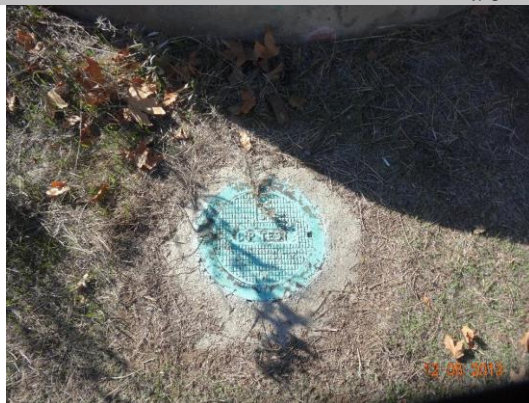
Photo 3 of 3 : UCIP_SP_2017_30124_55520.jpg

LM Start	1.95	Rating **	M	Issue No.	33 (cont)
LM End	1.95	Issue Type +	En	Location *	LS
Category	Supplemental			GPS Latitude/Longitude	
				Start	End
Item	DWR UCIP Field Study			38.561064 °	38.561064 °
				-121.417323 °	-121.417323 °
DWR ID					
Comment Code					
Inspector Comment					
FS_ID:30124					
DS_ID:24395					
EP_NO: N/A					
Repair Type: Non-Urgent					
Crossing Status: Indicator Found					
UCIP Comments: unable to confirm crossing--need to contact owner to determine status of crossing.					
FIELD_STRUCT_DESC: 60-inch sewer main through the American River overflow area. Erosion protection and rock revetment on waterside (WS) slope added under Permit No. 14487 (1986).					
FS Date: 12/5/2013

Small handhole found need concrete cylinder.

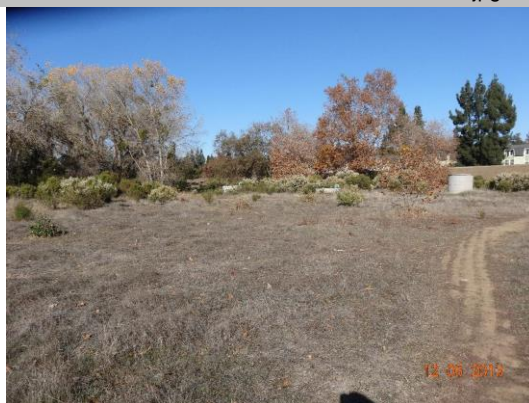
Photo 1 of 3 : UCIP_SP_2017_46085_54713.jpg

LM Start	1.96	Rating **	M	Issue No.	34
LM End	1.96	Issue Type +	En	Location *	LS
Category	Supplemental			GPS Latitude/Longitude	
				Start	End
Item	DWR UCIP Field Study			38.561119 °	38.561119 °
				-121.417581 °	-121.417581 °
DWR ID					
Comment Code					
Inspector Comment					
FS_ID:46085 DS_ID:24649 EP_NO: 12188 Repair Type: Non-Urgent Crossing Status: Indicator Found UCIP Comments: unable to confirm crossing--need to contact owner to determine specifics and status of crossing. FIELD_STRUCT_DESC: 60-inch steel sewer main under the levee, approximately 21.6 feet below the crown. Two concrete cutoff walls around pipe under each shoulder. (Permit No. 12188-1979) Erosion protection and rock revetment on waterside (WS) slope added under Permit No. 14487 (1986). FS Date: 12/5/2013

View of waterward berm.

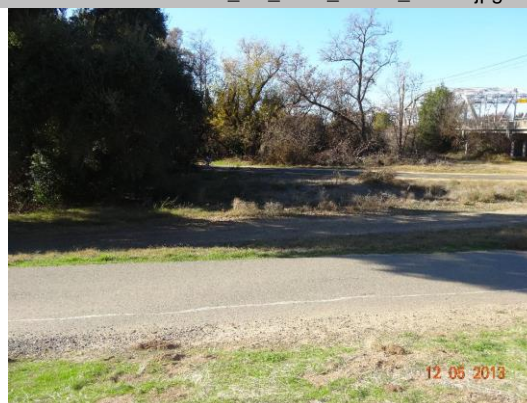
Photo 1 of 3 : UCIP_SP_2017_31309_57338.jpg

LM Start	2.51	Rating **	M	Issue No.	35
LM End	2.51	Issue Type +	En	Location *	LS
Category	Supplemental			GPS Latitude/Longitude	
				Start	End
Item	DWR UCIP Field Study			38.568767 °	38.568767 °
				-121.421178 °	-121.421178 °
DWR ID					
Comment Code					
Inspector Comment					
FS_ID:31309					
DS_ID:24515					
EP_NO: N/A					
Repair Type: Non-Urgent					
Crossing Status: Indicator Found					
UCIP Comments: Unable to confirm crossing. will need to contact owner to determine specifics and status of crossing.					
FIELD_STRUCT_DESC: 36-inch corrugated metal (CM) pipe through the levee. Riser unit on waterside (WS). (USACE-1959). This entry matches the Drainage or Irrigation Structure referenced in O&M manual (Station 365+14).					
FS Date: 12/5/2013

View of waterward side.

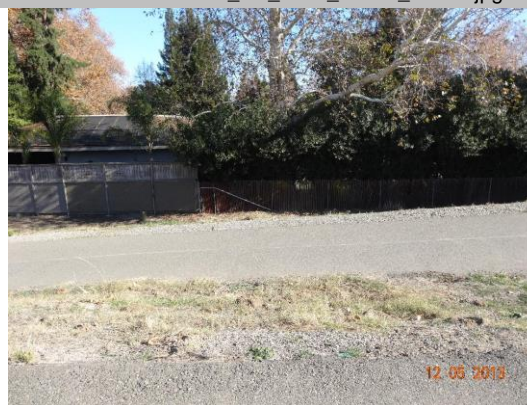
Photo 2 of 3 : UCIP_SP_2017_31309_57337.jpg

View of landward side.

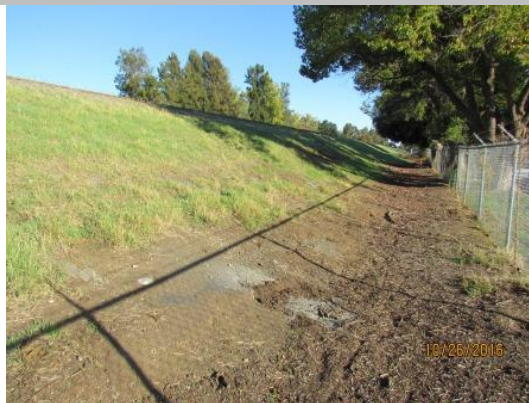
Photo 1 of 2 : SP_2017_NA0001_60_27_20170313_00008.jpg

LM Start	2.66	Rating **	A/W	Issue No.	27
LM End	2.66	Issue Type +	Ma	Location *	LS
Category	Earthen Levee			GPS Latitude/Longitude	
				Start	End
Item	Animal Control			38.570882 °	38.570882 °
				-121.420927 °	-121.420927 °
DWR ID	DWR_NA0001_09_s_2016_27				
Comment Code					
A1 : Exterminate rodents and backfill and compact or grout burrows.					
Inspector Comment					
LMA backfilled the rodent holes. This area should be monitored for possible rodent activity.

View of the rodent holes on the landside levee slope.

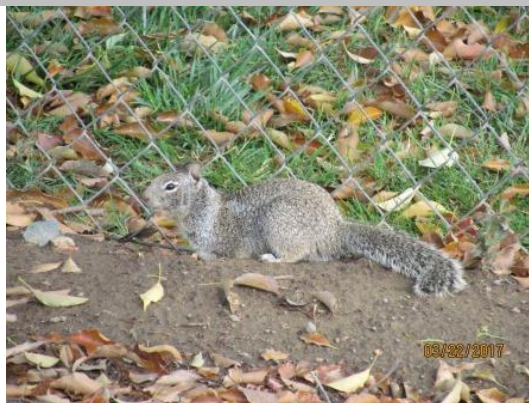
Photo 2 of 2 : SP_2017_NA0001_60_27_20170406_00045.jpg

View of the rodent at the levee toe causing levee damage.

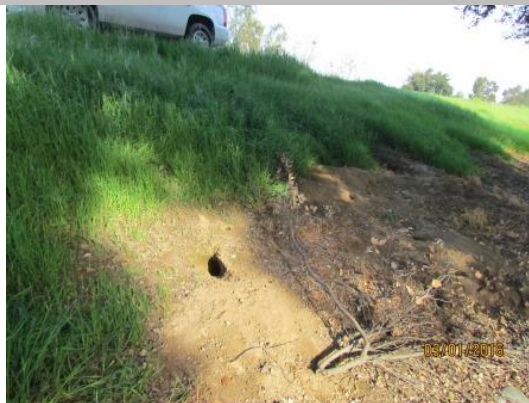
Photo 1 of 1 : SP_2017_NA0001_60_26_20170313_00007.jpg

LM Start	2.70	Rating **	M	Issue No.	26
LM End	2.70	Issue Type +	Ma	Location *	LS
Category	Earthen Levee			GPS Latitude/Longitude	
				Start	End
Item	Animal Control			38.571431 °	38.571431 °
				-121.420737 °	-121.420737 °
DWR ID	DWR_NA0001_09_s_2016_26				
Comment Code					
A1 : Exterminate rodents and backfill and compact or grout burrows.					
Inspector Comment					
LMA backfilled the rodent holes. This area should be monitored for possible rodent activity.

View of the rodent holes in the landside levee slope.

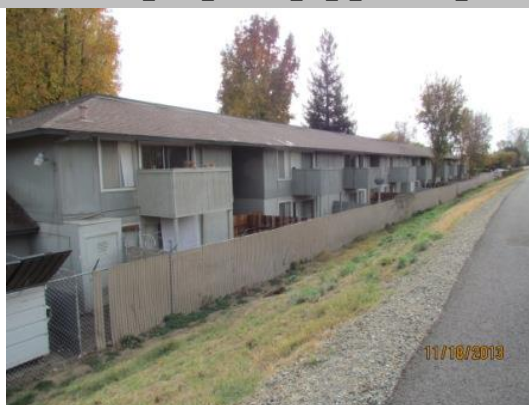
Photo 1 of 1 : SP_2017_NA0001_60_1_20170313_00001.jpg

LM Start	3.19	Rating **	U	Issue No.	1
LM End	3.27	Issue Type +	En	Location *	LS
Category	Earthen Levee			GPS Latitude/Longitude	
				Start	End
Item	Encroachments			38.578258 °	38.579363 °
				-121.418475 °	-121.418100 °
DWR ID	DWR_NA0001_09_s_2012_1				
Comment Code					
FE : Fence					
Inspector Comment

View of the fence at the landside levee toe.

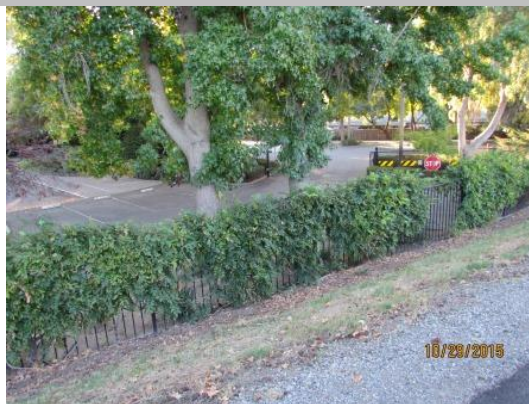
Photo 1 of 1 : SP_2017_NA0001_60_24_20170313_00006.jpg

LM Start	3.30	Rating **	M	Issue No.	24
LM End	3.30	Issue Type +	En	Location *	LS
Category	Earthen Levee			GPS Latitude/Longitude	
				Start	End
Item	Vegetation			38.579851 °	38.579851 °
				-121.417896 °	-121.417896 °
DWR ID	DWR_NA0001_09_f_2015_24				
Comment Code					
V6 : Landscaping					
Inspector Comment					
Vine on the LS fence blocking visibility.

View of the vines on the fence at the landside levee toe.

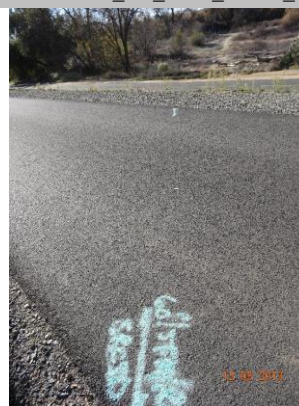
Photo 1 of 3 : UCIP_SP_2017_30125_55526.jpg

LM Start	3.32	Rating **	M	Issue No.	36
LM End	3.32	Issue Type +	En	Location *	LS
Category	Supplemental			GPS Latitude/Longitude	
				Start	End
Item	DWR UCIP Field Study			38.580094 °	38.580094 °
				-121.417821 °	-121.417821 °
DWR ID					
Comment Code					
Inspector Comment					
FS_ID:30125 DS_ID:24412 EP_NO: 17671 Repair Type: Non-Urgent Crossing Status: Indicator Found UCIP Comments: unable to confirm if manhole is part of this crossing--need to contact owner to determine status of crossing. FIELD_STRUCT_DESC: 1 of 2: 60-inch sewer main under the levee. Connects to 60-inch main on landside (LS). (Permit No. 17671-2003) FS Date: 12/5/2013

View of waterward side.

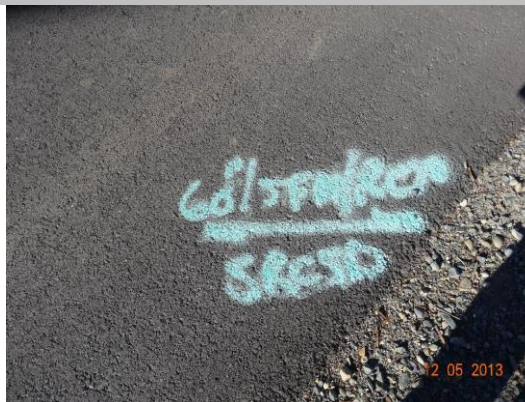
Photo 2 of 3 : UCIP_SP_2017_30125_55528.jpg

Underground service alert (USA) paint found on bike path on waterward side.

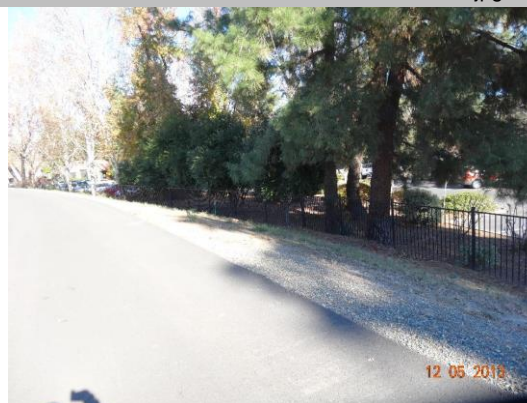
Photo 1 of 3 : UCIP_SP_2017_29633_54791.jpg

LM Start	3.34	Rating **	M	Issue No.	37
LM End	3.34	Issue Type +	En	Location *	LS
Category	Supplemental			GPS Latitude/Longitude	
				Start	End
Item	DWR UCIP Field Study			38.580347 °	38.580347 °
				-121.417734 °	-121.417734 °
DWR ID					
Comment Code					
Inspector Comment					
FS_ID:29633 DS_ID:24404 EP_NO: 12188 Repair Type: Non-Urgent Crossing Status: Indicator Found UCIP Comments: unable to confirm if crossing is still active--need to contact owner to determine status of crossing. FIELD_STRUCT_DESC: 60-inch concrete encased steel sewer line through the levee, 17.0 feet below the crown. Cutoff wall around pipe at the center of the levee. Rock revetment on waterside (WS) slope. Three pressure manholes in overflow area along pipe path. (Permit No. 12188-1979) FS Date: 12/5/2013

View of landward side.

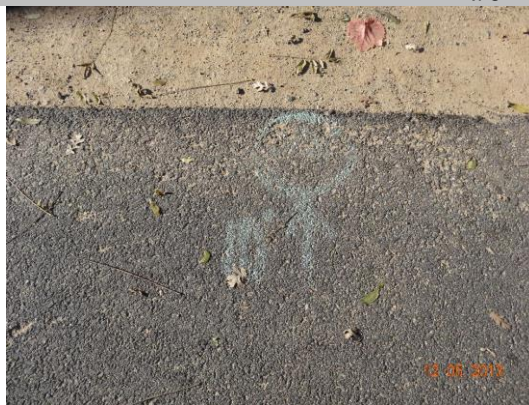
Photo 3 of 3 : UCIP_SP_2017_29633_54789.jpg

Faded paint markings located on levee crown.

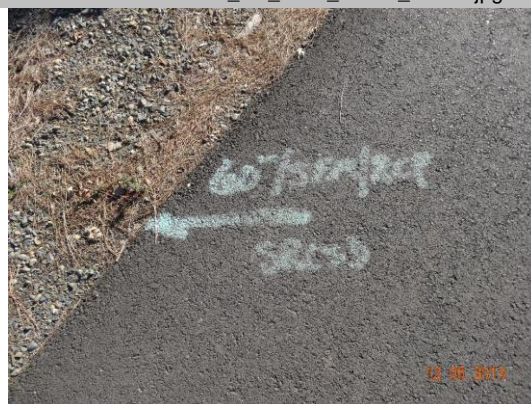
Photo 2 of 3 : UCIP_SP_2017_41437_55531.jpg

Underground service alert (USA) markings found on levee crown for 60-inch pipe.

LM Start	3.34	Rating **	M	Issue No.	38 (cont)	
LM End	3.34	Issue Type +	En	Location *	LS	
Category	Supplemental			GPS Latitude/Longitude		
				Start	End	
Item	DWR UCIP Field Study			38.580435 °	38.580435 °	
				-121.417711 °	-121.417711 °	
DWR ID						
Comment Code						
Inspector Comment						
FS_ID:41437 DS_ID:24566 EP_NO: 17671 Repair Type: Non-Urgent Crossing Status: Indicator Found UCIP Comments: Need to confirm location with owner. FIELD_STRUCT_DESC: 2 of 2: 60-inch sewer main under the levee. Connects to 60-inch main on landside (LS). (Permit No. 17671-2003) FS Date: 12/5/2013

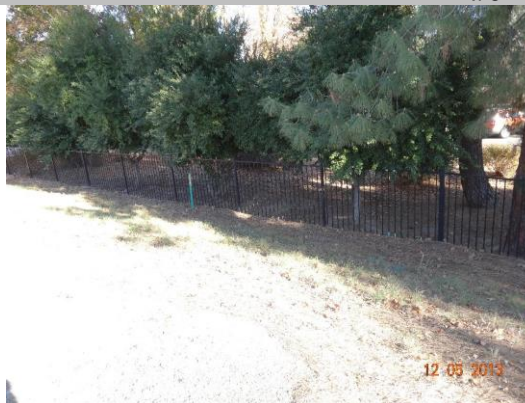
Photo 3 of 3 : UCIP_SP_2017_41437_55530.jpg

Marker visible on landward.

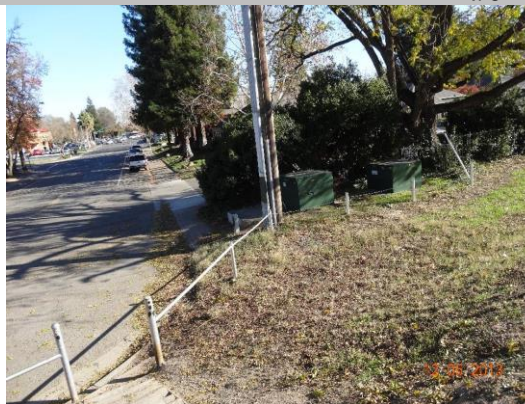
Photo 1 of 2 : UCIP_SP_2017_30684_56473.jpg

LM Start	3.42	Rating **	M	Issue No.	39
LM End	3.42	Issue Type +	En	Location *	LS
Category	Supplemental			GPS Latitude/Longitude	
				Start	End
Item	DWR UCIP Field Study			38.581572 °	38.581572 °
				-121.417819 °	-121.417819 °
DWR ID					
Comment Code					
Inspector Comment					
FS_ID:30684 DS_ID:24816 EP_NO: N/A Repair Type: Non-Urgent Crossing Status: Indicator Found UCIP Comments: unable to determine if crossing goes through levee. Need to obtain additional information to confirm crossing. FIELD_STRUCT_DESC: Water fountain found on waterside (WS). FS Date: 12/5/2013

View of landward side.

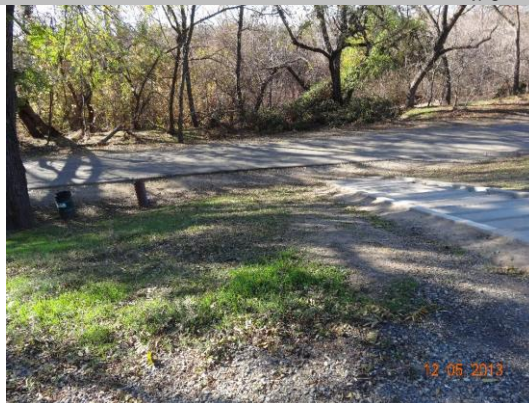
Photo 2 of 2 : UCIP_SP_2017_30684_56472.jpg

LM Start	3.42	Rating **	M	Issue No.	39 (cont)	
LM End	3.42	Issue Type +	En	Location *	LS	
Category	Supplemental			GPS Latitude/Longitude		
				Start		End
Item	DWR UCIP Field Study			38.581572 °		38.581572 °
				-121.417819 °		-121.417819 °
DWR ID						
Comment Code						
Inspector Comment						
FS_ID:30684 DS_ID:24816 EP_NO: N/A Repair Type: Non-Urgent Crossing Status: Indicator Found UCIP Comments: unable to determine if crossing goes through levee. Need to obtain additional information to confirm crossing. FIELD_STRUCT_DESC: Water fountain found on waterside (WS). FS Date: 12/5/2013

View of waterward side.

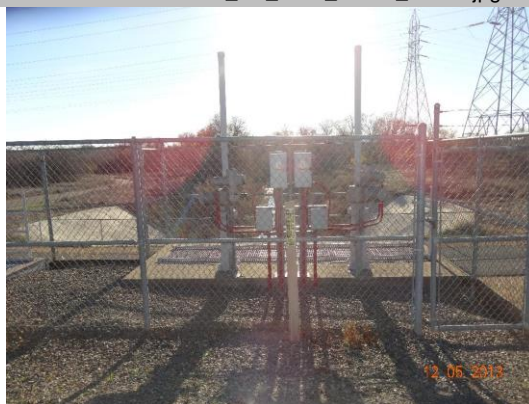
Photo 1 of 3 : UCIP_SP_2017_31304_57325.jpg

LM Start	3.68	Rating **	M	Issue No.	40
LM End	3.68	Issue Type +	En	Location *	LS
Category	Supplemental			GPS Latitude/Longitude	
				Start	End
Item	DWR UCIP Field Study			38.584344 °	38.584344 °
				-121.420968 °	-121.420968 °
DWR ID					
Comment Code					
Inspector Comment					
FS_ID:31304 DS_ID:24817 EP_NO: N/A Repair Type: Non-Urgent Crossing Status: Found UCIP Comments: Need to confirm crossing size--need additional information about crossing. FIELD_STRUCT_DESC: 1 of 2: Crossing through levee at unknown depth. Concrete structure (7x15-foot) located on waterside (WS) shoulder with slide gate inside manhole. Square flap gate located on WS end. Concrete wings and apron at WS end of outlet channel. Concrete box located on the WS shoulder fenced off. FS Date: 12/5/2013

Concrete box and electrical box located on waterward shoulder.

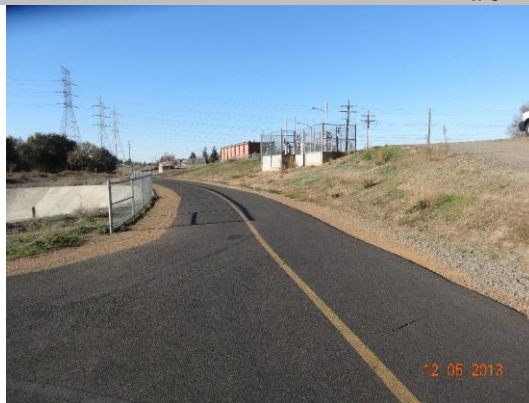
Photo 2 of 3 : UCIP_SP_2017_31304_57320.jpg

LM Start	3.68	Rating **	M	Issue No.	40 (cont)	
LM End	3.68	Issue Type +	En	Location *	LS	
Category	Supplemental			GPS Latitude/Longitude		
				Start		End
Item	DWR UCIP Field Study			38.584344 °		38.584344 °
				-121.420968 °		-121.420968 °
DWR ID						
Comment Code						
Inspector Comment						
FS_ID:31304 DS_ID:24817 EP_NO: N/A Repair Type: Non-Urgent Crossing Status: Found UCIP Comments: Need to confirm crossing size--need additional information about crossing. FIELD_STRUCT_DESC: 1 of 2: Crossing through levee at unknown depth. Concrete structure (7x15-foot) located on waterside (WS) shoulder with slide gate inside manhole. Square flap gate located on WS end. Concrete wings and apron at WS end of outlet channel. Concrete box located on the WS shoulder fenced off. FS Date: 12/5/2013

Bike path located on waterward side.

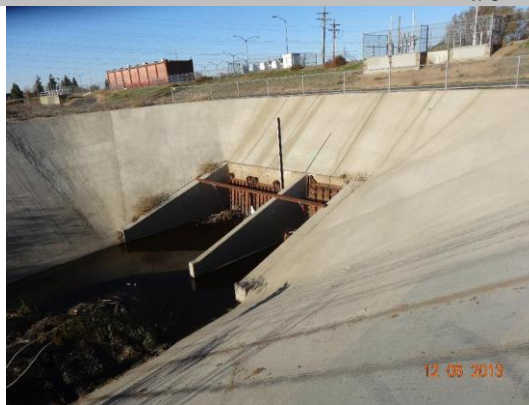
Photo 3 of 3 : UCIP_SP_2017_31304_57324.jpg

Concrete wall and wing walls located on waterward side.

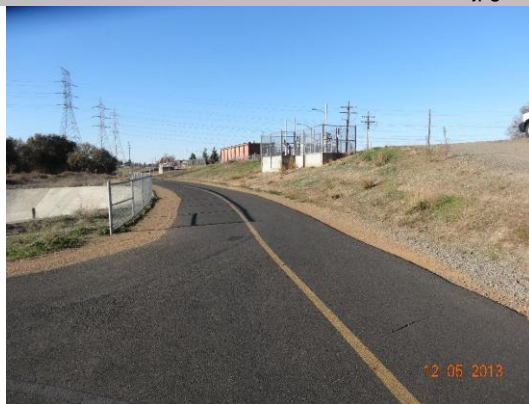
Photo 2 of 3 : UCIP_SP_2017_31306_57328.jpg

LM Start	3.69	Rating **	M	Issue No.	41
LM End	3.69	Issue Type +	En	Location *	LS
Category	Supplemental			GPS Latitude/Longitude	
				Start	End
Item	DWR UCIP Field Study			38.584355 °	38.584355 °
				-121.420989 °	-121.420989 °
DWR ID					
Comment Code					
Inspector Comment					
FS_ID:31306 DS_ID:24818 EP_NO: N/A Repair Type: Non-Urgent Crossing Status: Found UCIP Comments: Unable to confirm pipe size--need additional information about crossing. FIELD_STRUCT_DESC: 2 of 2: Crossing through levee at unknown depth. Concrete structure (7x15-foot) located on waterside (WS) shoulder with slide gate inside manhole. Square flap gate located on WS end. Concrete wings and apron at WS end of outlet channel. Concrete box located on the WS shoulder fenced off. No permit was found for this crossing. FS Date: 12/5/2013

Bike path located on waterward side.

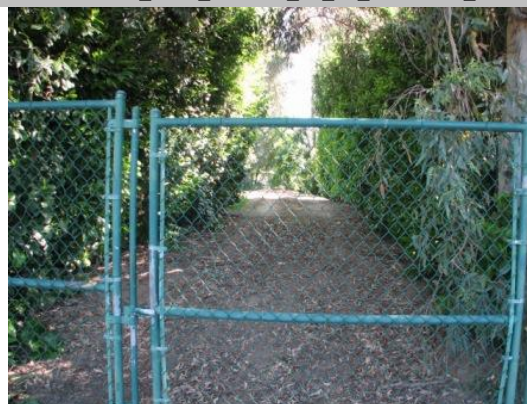
Photo 1 of 1 : SP_2017_NA0001_61_16_20170313_00002.jpg

LM Start	0.00	Rating **	U	Issue No.	16
LM End	0.62	Issue Type +	En	Location *	CR
Category	Earthen Levee			GPS Latitude/Longitude	
				Start	End
Item	Encroachments			38.600917 °	38.592184 °
				-121.332100 °	-121.334347 °
DWR ID	DWR_NA0001_10_s_2012_16				
Comment Code					
UR : Urban					
Inspector Comment

Levee encroached on by property owners north of Arden Way. This section is not reasonably accessible.

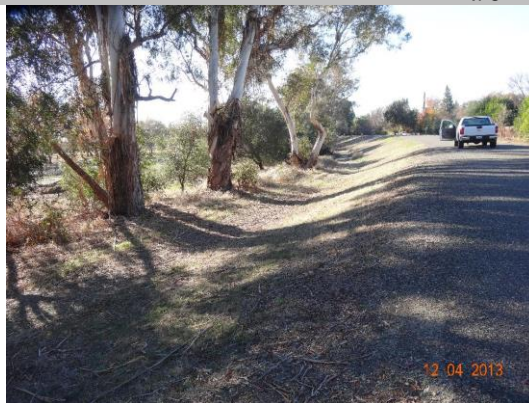
Photo 1 of 3 : UCIP_SP_2017_26281_47492.jpg

LM Start	0.72	Rating **	M	Issue No.	119
LM End	0.72	Issue Type +	En	Location *	CR
Category	Supplemental			GPS Latitude/Longitude	
				Start	End
Item	DWR UCIP Field Study			38.591003 °	38.591003 °
				-121.335459 °	-121.335459 °
DWR ID					
Comment Code					
Inspector Comment					
FS_ID:26281 DS_ID:24464 EP_NO: 12725 Repair Type: Non-Urgent Crossing Status: Indicator Found UCIP Comments: Unable to confirm if this crossing is the same under permit 12725. Drinking fountain and water flow prevention located on waterward side. Need to coordinate with American River Flood Control District. FIELD_STRUCT_DESC: 6-inch steel water pipe through the levee, 2.5 feet below the crown. Arcade Water District well at landside (LS) toe. (Permit No. 12725-1980) FS Date: 12/4/2013

View of waterward slope.

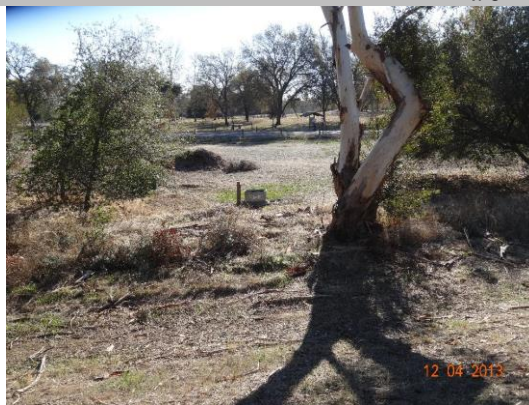
Photo 2 of 3 : UCIP_SP_2017_26281_47493.jpg

View of faucet located on waterward side.

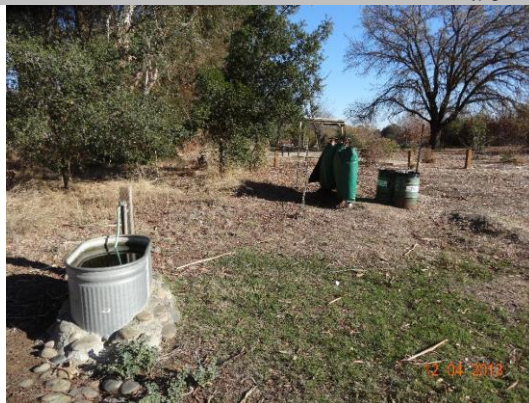
Photo 3 of 3 : UCIP_SP_2017_26281_47491.jpg

LM Start	0.72	Rating **	M	Issue No.	119 (cont)
LM End	0.72	Issue Type +	En	Location *	CR
Category	Supplemental			GPS Latitude/Longitude	
				Start	End
Item	DWR UCIP Field Study			38.591003 °	38.591003 °
				-121.335459 °	-121.335459 °
DWR ID					
Comment Code					
Inspector Comment					
FS_ID:26281 DS_ID:24464 EP_NO: 12725 Repair Type: Non-Urgent Crossing Status: Indicator Found UCIP Comments: Unable to confirm if this crossing is the same under permit 12725. Drinking fountain and water flow prevention located on waterward side. Need to coordinate with American River Flood Control District. FIELD_STRUCT_DESC: 6-inch steel water pipe through the levee, 2.5 feet below the crown. Arcade Water District well at landside (LS) toe. (Permit No. 12725-1980) FS Date: 12/4/2013

View of waterward side--faucet and water flow prevention system.

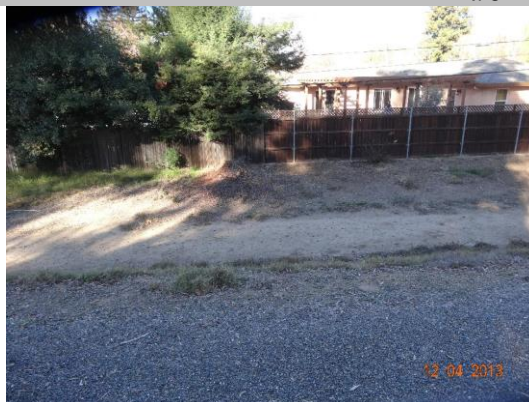
Photo 1 of 3 : UCIP_SP_2017_41550_47496.jpg

LM Start	0.94	Rating **	M	Issue No.	120
LM End	0.94	Issue Type +	En	Location *	CR
Category	Supplemental			GPS Latitude/Longitude	
				Start	End
Item	DWR UCIP Field Study			38.587989 °	38.587989 °
				-121.336773 °	-121.336773 °
DWR ID					
Comment Code					
Inspector Comment					
FS_ID:41550 DS_ID:24413 EP_NO: 2806 Repair Type: Non-Urgent Crossing Status: Found UCIP Comments: Need to determine status of crossing--Need to coordinate with utility owner. FIELD_STRUCT_DESC: 30-inch corrugated metal (CM) pipe through the levee, 15.0 feet below the crown. Cutoff wall around pipe under landside (LS) shoulder. Flap gate and slide gate in concrete pipe well on the waterside (WS) shoulder. Large drain canal cut across the WS berm. (Permit No. 2806-1958) FS Date: 12/4/2013

View of landward side.

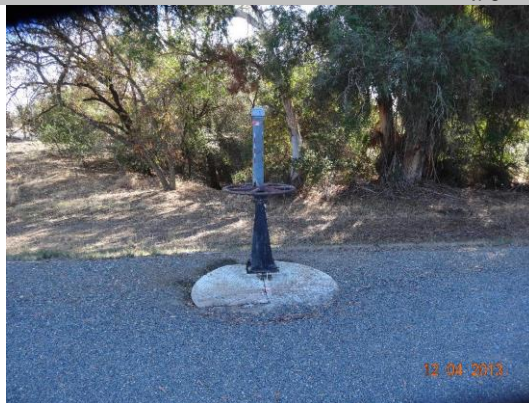
Photo 2 of 3 : UCIP_SP_2017_41550_47495.jpg

LM Start	0.94	Rating **	M	Issue No.	120 (cont)	
LM End	0.94	Issue Type +	En	Location *	CR	
Category	Supplemental			GPS Latitude/Longitude		
				Start		End
Item	DWR UCIP Field Study			38.587989 °		38.587989 °
				-121.336773 °		-121.336773 °
DWR ID						
Comment Code						
Inspector Comment						
FS_ID:41550 DS_ID:24413 EP_NO: 2806 Repair Type: Non-Urgent Crossing Status: Found UCIP Comments: Need to determine status of crossing--Need to coordinate with utility owner. FIELD_STRUCT_DESC: 30-inch corrugated metal (CM) pipe through the levee, 15.0 feet below the crown. Cutoff wall around pipe under landside (LS) shoulder. Flap gate and slide gate in concrete pipe well on the waterside (WS) shoulder. Large drain canal cut across the WS berm. (Permit No. 2806-1958) FS Date: 12/4/2013

View of gate stem located on waterward shoulder.

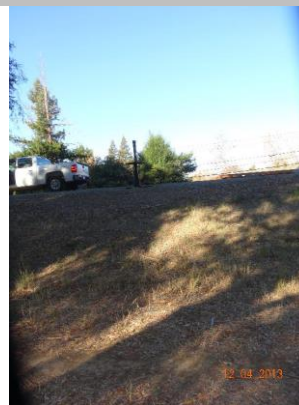
Photo 3 of 3 : UCIP_SP_2017_41550_47499.jpg

View of waterward slope.

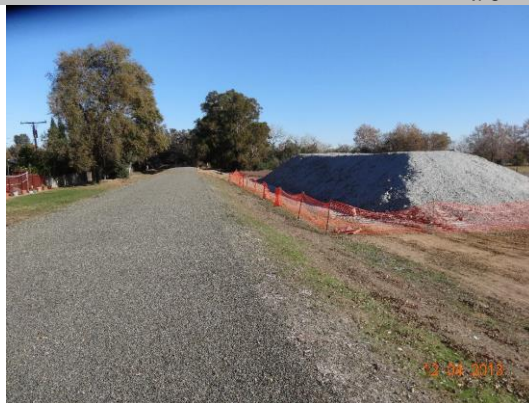
Photo 1 of 3 : UCIP_SP_2017_31284_57285.jpg

LM Start	1.04	Rating **	M	Issue No.	121
LM End	1.04	Issue Type +	En	Location *	CR
Category	Supplemental			GPS Latitude/Longitude	
				Start	End
Item	DWR UCIP Field Study			38.586813 °	38.586813 °
				-121.337643 °	-121.337643 °
DWR ID					
Comment Code					
Inspector Comment					
FS_ID:31284 DS_ID:24821 EP_NO: N/A Repair Type: Non-Urgent Crossing Status: Found UCIP Comments: Unable to determine reason for box and whether there is a utility that crosses levee. No permit found. FIELD_STRUCT_DESC: Service box located on waterside (WS). No permit found. FS Date: 12/4/2013

Overview of levee crown at crossing.

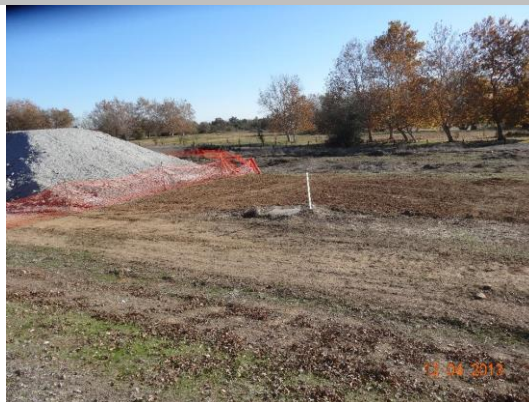
Photo 2 of 3 : UCIP_SP_2017_31284_57286.jpg

Concrete vault located on waterward side.

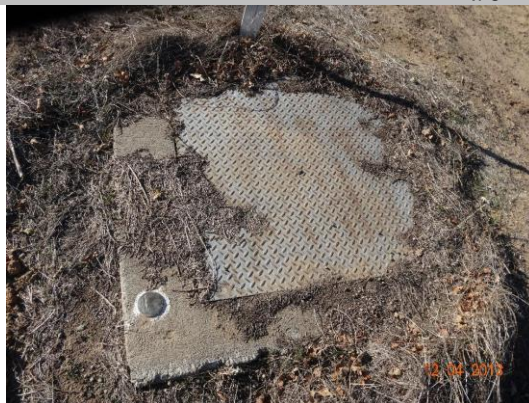
Photo 3 of 3 : UCIP_SP_2017_31284_57288.jpg

LM Start	1.04	Rating **	M	Issue No.	121 (cont)
LM End	1.04	Issue Type +	En	Location *	CR
Category	Supplemental			GPS Latitude/Longitude	
				Start	End
Item	DWR UCIP Field Study			38.586813 °	38.586813 °
				-121.337643 °	-121.337643 °
DWR ID					
Comment Code					
Inspector Comment					
FS_ID:31284 DS_ID:24821 EP_NO: N/A Repair Type: Non-Urgent Crossing Status: Found UCIP Comments: Unable to determine reason for box and whether there is a utility that crosses levee. No permit found. FIELD_STRUCT_DESC: Service box located on waterside (WS). No permit found. FS Date: 12/4/2013

Close up of concrete box located on waterward side.

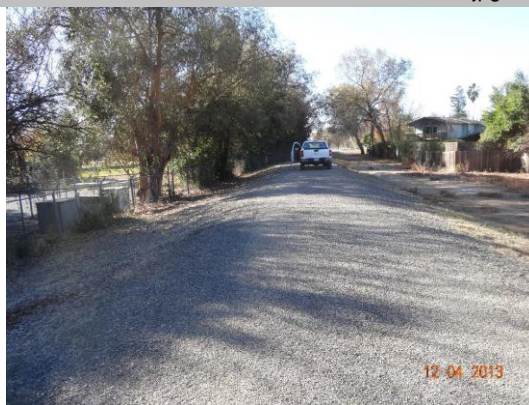
Photo 1 of 3 : UCIP_SP_2017_41536_47550.jpg

LM Start	1.28	Rating **	M	Issue No.	122
LM End	1.28	Issue Type +	En	Location *	CR
Category	Supplemental			GPS Latitude/Longitude	
				Start	End
Item	DWR UCIP Field Study			38.583873 °	38.583873 °
				-121.340037 °	-121.340037 °
DWR ID					
Comment Code					
Inspector Comment					
FS_ID:41536					
DS_ID:24097					
EP_NO: 12276					
Repair Type: Non-Urgent					
Crossing Status: Indicator Found					
UCIP Comments: Unable to find markers indicating crossing through levee.					
FIELD_STRUCT_DESC: Two 3-inch PVC electrical conduits through the levee, 3.0 feet below the crown. Northeast Sewage Treatment Plant on waterside (WS). Conduits extend from treatment plant to transformers located on WS. (Permit No. 12276-1980)					
FS Date: 12/4/2013

Overview of levee looking downstream.

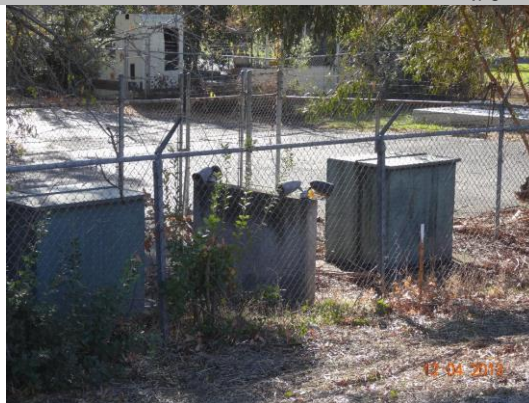
Photo 2 of 3 : UCIP_SP_2017_41536_47549.jpg

LM Start	1.28	Rating **	M	Issue No.	122 (cont)
LM End	1.28	Issue Type +	En	Location *	CR
Category	Supplemental			GPS Latitude/Longitude	
				Start	End
Item	DWR UCIP Field Study			38.583873 °	38.583873 °
				-121.340037 °	-121.340037 °
DWR ID					
Comment Code					
Inspector Comment					
FS_ID:41536 DS_ID:24097 EP_NO: 12276 Repair Type: Non-Urgent Crossing Status: Indicator Found UCIP Comments: Unable to find markers indicating crossing through levee. FIELD_STRUCT_DESC: Two 3-inch PVC electrical conduits through the levee, 3.0 feet below the crown. Northeast Sewage Treatment Plant on waterside (WS). Conduits extend from treatment plant to transformers located on WS. (Permit No. 12276-1980) FS Date: 12/4/2013

View of transformers located on waterward side.

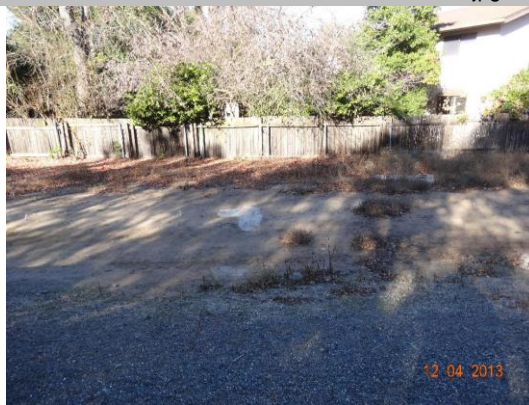
Photo 3 of 3 : UCIP_SP_2017_41536_47551.jpg

View of landward side.

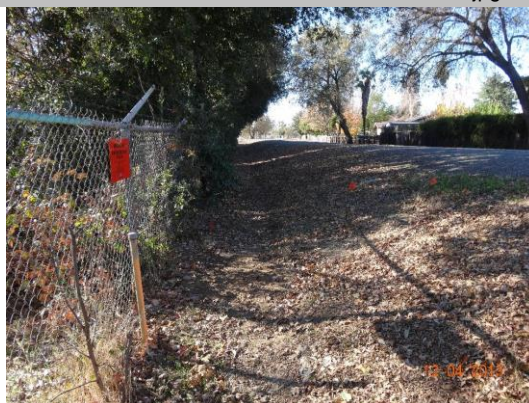
Photo 2 of 3 : UCIP_SP_2017_26299_47574.jpg

View of waterward side--Underground Alert System markers showing alignment.

LM Start	1.28	Rating **	M	Issue No.	123 (cont)
LM End	1.28	Issue Type +	En	Location *	CR
Category	Supplemental			GPS Latitude/Longitude	
				Start	End
Item	DWR UCIP Field Study			38.583873 °	38.583873 °
				-121.340037 °	-121.340037 °
DWR ID					
Comment Code					
Inspector Comment					
FS_ID:26299 DS_ID:24477 EP_NO: 7993 Repair Type: Non-Urgent Crossing Status: Found UCIP Comments: Unable to confirm if crossing buried is the same as this crossing. Need to contact owner to confirm utility description. FIELD_STRUCT_DESC: 6-inch plastic lined steel pipe through the levee at unknown depth. Steel cutoff wall around pipe at center of levee. (Permit No. 7993-1973) FS Date: 12/4/2013

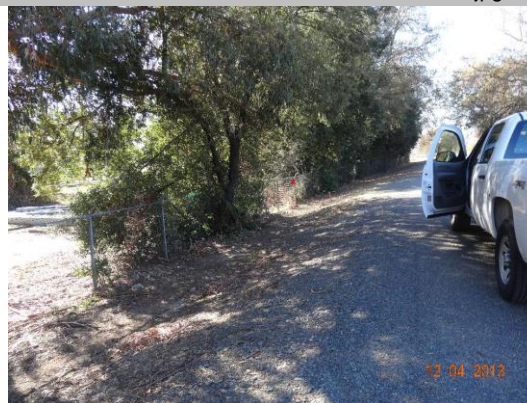
Photo 2 of 3 : UCIP_SP_2017_26296_47559.jpg

View of waterward side.

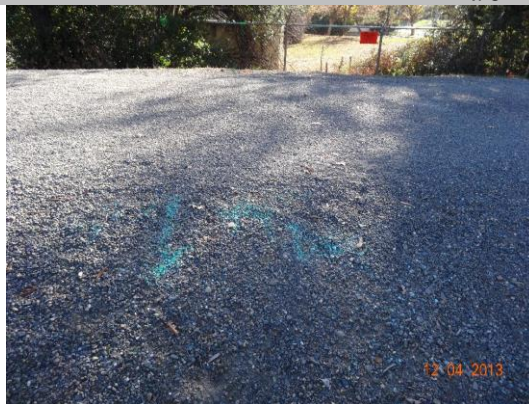
Photo 2 of 3 : UCIP_SP_2017_26298_47571.jpg

Comment Code					
Inspector Comment					
FS_ID:26298 DS_ID:24567 EP_NO: 3599A Repair Type: Non-Urgent Crossing Status: Found UCIP Comments: Need to determine status of structure. Need to coordinate with owner to determine maintenance records to confirm integrity. FIELD_STRUCT_DESC: 2 of 3: [River Walkway Station] 36-inch concrete encased pipe through the levee, 6.9 feet below the crown. Two cutoff walls around pipe in line with each shoulder. Slide gate in concrete gate structure at landside (LS) toe. Sewage treatment plant on waterside (WS). Control valve in concrete box on the WS. (Permit No. 3599A-1964) Contact: Sacramento Regional Office 875-9400; Oscar Starks (Supervisor) 916-204-5143; Troy Shurock 916-599-2413. FS Date: 12/4/2013

USA markers indicate alignment through levee crown.

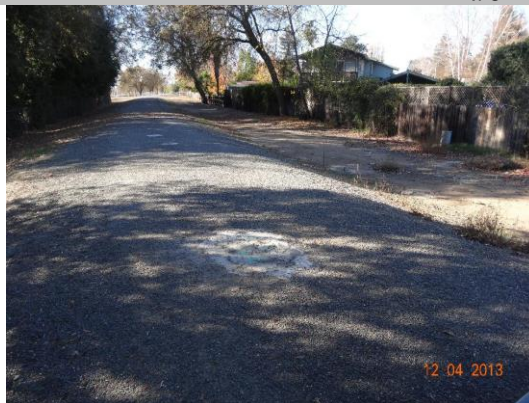
Photo 3 of 3 : UCIP_SP_2017_26298_47568.jpg

Item	DWR UCIP Field Study			38.583750 °		38.583750 °
				-121.340143 °		-121.340143 °
DWR ID						
Comment Code						
Inspector Comment						
FS_ID:26298						
DS_ID:24567						
EP_NO: 3599A						
Repair Type: Non-Urgent						
Crossing Status: Found						
UCIP Comments: Need to determine status of structure. Need to coordinate with owner to determine maintenance records to confirm integrity.						
FIELD_STRUCT_DESC: 2 of 3: [River Walkway Station] 36-inch concrete encased pipe through the levee, 6.9 feet below the crown. Two cutoff walls around pipe in line with each shoulder. Slide gate in concrete gate structure at landside (LS) toe. Sewage treatment plant on waterside (WS). Control valve in concrete box on the WS. (Permit No. 3599A-1964) Contact: Sacramento Regional Office 875-9400; Oscar Starks (Supervisor) 916-204-5143; Troy Shurock 916-599-2413.						
FS Date: 12/4/2013

Overview of levee crown with grout holes visible at the crown along pipe alignment.

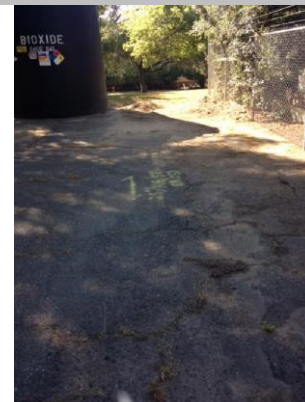
Photo 1 of 3 : UCIP_SP_2017_50053_75902.jpg

LM Start	1.29	Rating **	M	Issue No.	128
LM End	1.29	Issue Type +	En	Location *	CR
Category	Supplemental			GPS Latitude/Longitude	
				Start	End
Item	DWR UCIP Field Study			38.583728 °	38.583728 °
				-121.340178 °	-121.340178 °
DWR ID					
Comment Code					
Inspector Comment					
FS_ID:50053 DS_ID:25449 EP_NO: N/A Repair Type: Non-Urgent Crossing Status: Indicator Found UCIP Comments: FIELD_STRUCT_DESC: 3-inch diameter plastic vynal conduit chlorine line sleeved through steel pipe through the right bank of the levee 2 feet below crown. (Permit No. 4535-1964, Northeast Sacramento County Sanitation District) Contact: Sacramento Reginal Office 875-9400; Oscar Starks (Supervisor) 916-204-5143; Troy Shurock 916-599-2413. FS Date: 4/1/2016

WS View - underground service alert (USA) markings indicating pipe alignment.

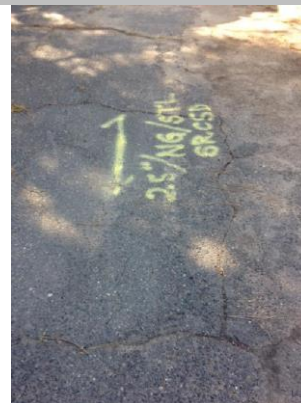
Photo 2 of 3 : UCIP_SP_2017_50053_75903.jpg

USA markings indicate 2.5-inch steel line.

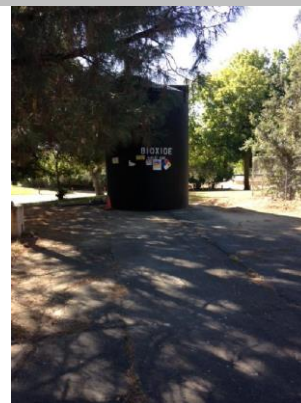
Photo 3 of 3 : UCIP_SP_2017_50053_75904.jpg

Storage tank located on WS.

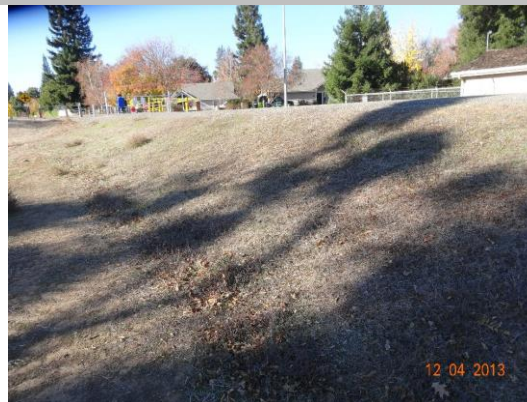
Photo 2 of 3 : UCIP_SP_2017_41548_54881.jpg

View of waterward side.

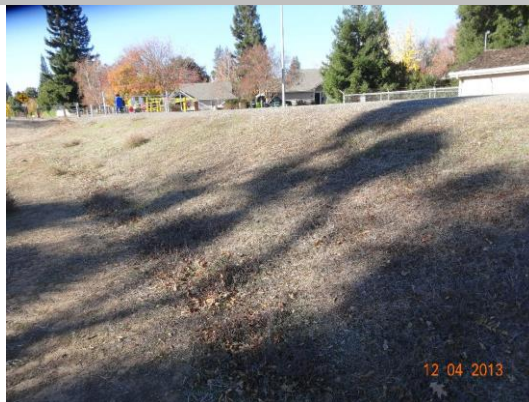
Photo 3 of 3 : UCIP_SP_2017_41546_57291.jpg

View of waterward side.

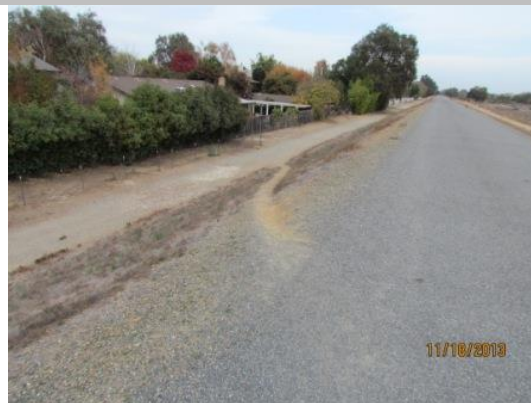
Photo 1 of 1 : SP_2017_NA0001_61_7_20170313_00001.jpg

LM Start	2.41	Rating **	A/W	Issue No.	7
LM End	2.41	Issue Type +	Ma	Location *	LS
Category	Earthen Levee			GPS Latitude/Longitude	
				Start	End
Item	Slope Stability			38.575126 °	38.575126 °
				-121.357575 °	-121.357575 °
DWR ID	DWR_NA0001_10_f_2013_7				
Comment Code					
S2 : Repair the levee slope damaged by foot traffic and prevent access where possible.					
Inspector Comment

View of the pathway on the landside levee slope.

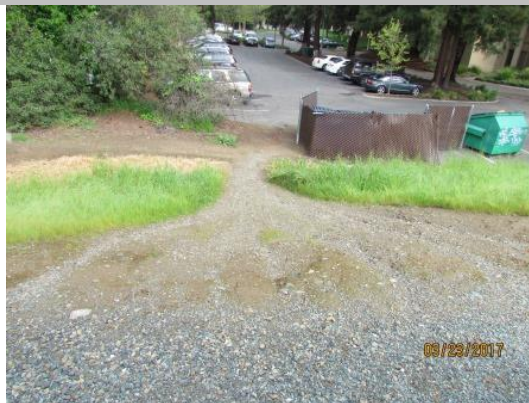
Photo 1 of 1 : SP_2017_NA0001_61_116_20170406_00046.jpg

LM Start	3.74	Rating **	M	Issue No.	116
LM End	3.74	Issue Type +	Ma	Location *	LS
Category	Earthen Levee			GPS Latitude/Longitude	
				Start	End
Item	Slope Stability			38.568526 °	38.568526 °
				-121.380331 °	-121.380331 °
DWR ID	DWR_NA0001_10_s_2012_116				
Comment Code					
S2 : Repair the levee slope damaged by foot traffic and prevent access where possible.					
Inspector Comment					
Foot traffic is eroding the landside slope.

View of the erosion on the landside levee slope caused by pedestrian foot traffic.

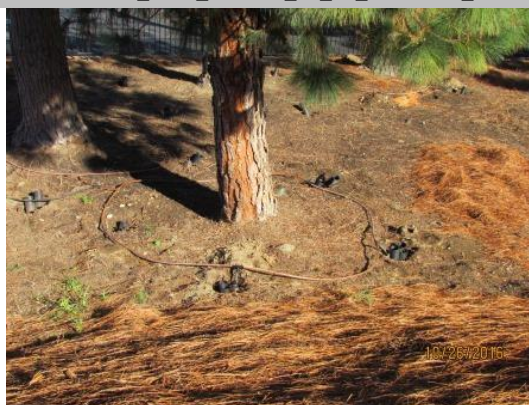
Photo 1 of 1 : SP_2017_NA0001_61_27_20170313_00006.jpg

LM Start	3.76	Rating **	M	Issue No.	27
LM End	3.76	Issue Type +	En	Location *	LS
Category	Earthen Levee			GPS Latitude/Longitude	
				Start	End
Item	Encroachments			38.568413 °	38.568413 °
				-121.380711 °	-121.380711 °
DWR ID	DWR_NA0001_10_f_2016_27				
Comment Code					
LI : Landscape Irrigation					
Inspector Comment

View of the landscaping irrigation at the landside levee toe.

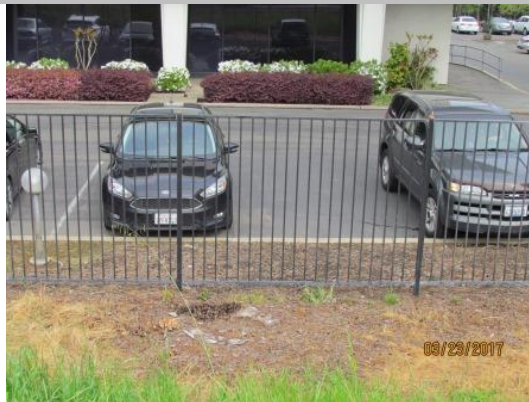
Photo 1 of 1 : SP_2017_NA0001_61_28_20170406_00045.jpg

LM Start	3.77	Rating **	N	Issue No.	28
LM End	3.77	Issue Type +	Ma	Location *	LS
Category	Earthen Levee			GPS Latitude/Longitude	
				Start	End
Item	Trim / Thin Trees			38.568375 °	38.568375 °
				-121.380889 °	-121.380889 °
DWR ID	DWR_NA0001_10_s_2017_28				
Comment Code					
T5 : Tree stumps.					
Inspector Comment

View of the tree stump at the levee toe.

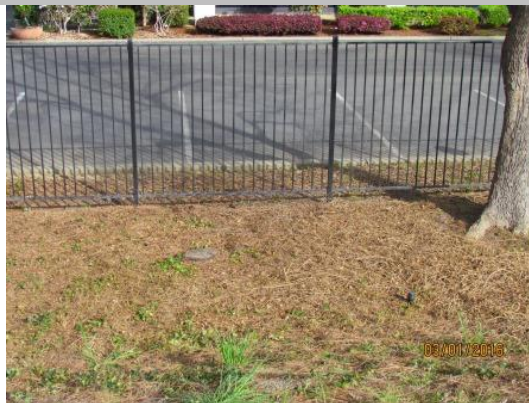
Photo 1 of 1 : SP_2017_NA0001_61_26_20170313_00005.jpg

LM Start	3.81	Rating **	N	Issue No.	26
LM End	3.81	Issue Type +	Ma	Location *	LS
Category	Earthen Levee			GPS Latitude/Longitude	
				Start	End
Item	Trim / Thin Trees			38.568190 °	38.568190 °
				-121.381510 °	-121.381510 °
DWR ID	DWR_NA0001_10_s_2016_26				
Comment Code					
T5 : Tree stumps.					
Inspector Comment

View of the tree stump at the landside levee toe.

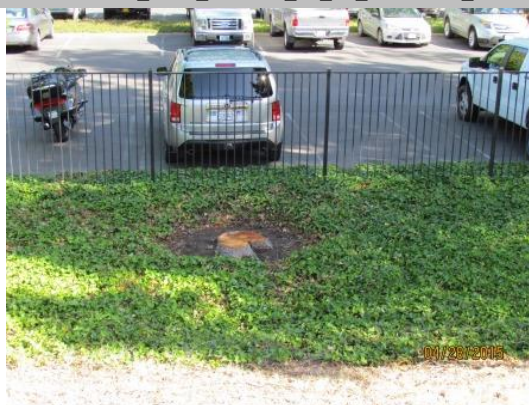
Photo 1 of 1 : SP_2017_NA0001_61_23_20170313_00004.jpg

LM Start	3.83	Rating **	N	Issue No.	23
LM End	3.83	Issue Type +	Ma	Location *	LS
Category	Earthen Levee			GPS Latitude/Longitude	
				Start	End
Item	Trim / Thin Trees			38.568111 °	38.568111 °
				-121.381896 °	-121.381896 °
DWR ID	DWR_NA0001_10_s_2015_23				
Comment Code					
T5 : Tree stumps.					
Inspector Comment

View of the tree stump at the landside levee toe.

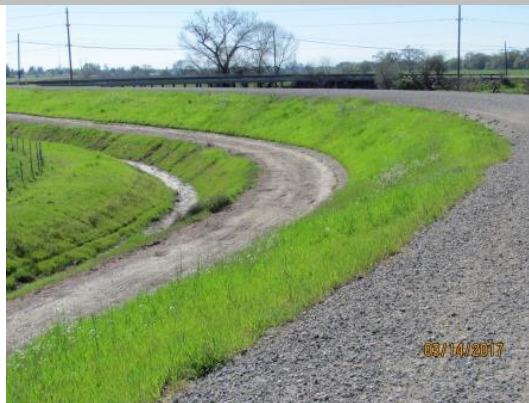
Photo 1 of 1 : SP_2017_NA0001_436_5_20170327_00009.jpg

LM Start	0.01	Rating **	A	Issue No.	5
LM End	0.60	Issue Type +	Ma	Location *	LS
Category	Earthen Levee			GPS Latitude/Longitude	
				Start	End
Item	Vegetation			38.662551 °	38.667877 °
				-121.457606 °	-121.449877 °
DWR ID	DWR_NA0001_11_s_2017_5				
Comment Code					
V1 : Control annual grass and weeds on the levee slopes and easements.					
Inspector Comment

View of the acceptable vegetation on the landside levee slope.

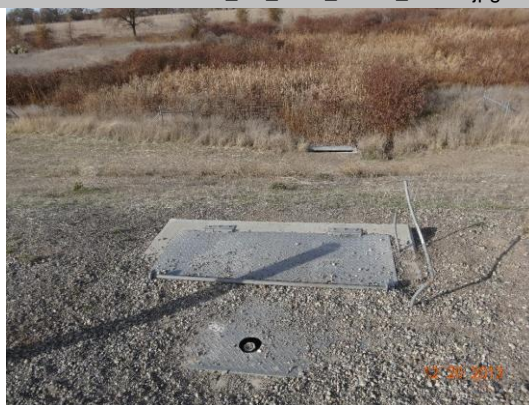
Photo 1 of 3 : UCIP_SP_2017_31310_57345.jpg

LM Start	0.08	Rating **	M	Issue No.	6
LM End	0.08	Issue Type +	En	Location *	LS
Category	Supplemental			GPS Latitude/Longitude	
				Start	End
Item	DWR UCIP Field Study			38.662976 °	38.662976 °
				-121.456464 °	-121.456464 °
DWR ID					
Comment Code					
Inspector Comment					
FS_ID:31310 DS_ID:24823 EP_NO: N/A Repair Type: Non-Urgent Crossing Status: Found UCIP Comments: no permit found--owner? (unauthorized?) FIELD_STRUCT_DESC: 24-inch pipe through the levee at unknown depth. Concrete box located on waterside (WS) shoulder. Concrete wall located on waterside (WS) and landside (LS). Siphon breaker inside concrete service box located on WS shoulder. No permit found. FS Date: 12/20/2013

View of waterward side.

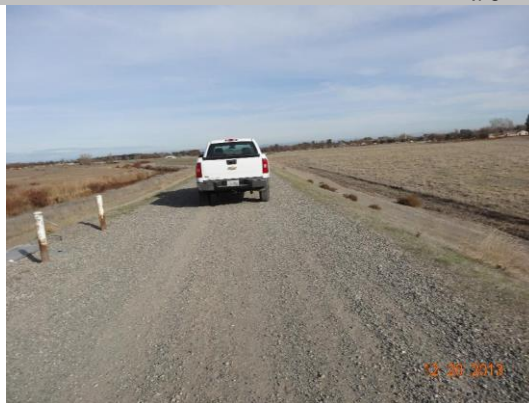
Photo 2 of 3 : UCIP_SP_2017_31310_57342.jpg

LM Start	0.08	Rating **	M	Issue No.	6 (cont)	
LM End	0.08	Issue Type +	En	Location *	LS	
Category	Supplemental			GPS Latitude/Longitude		
				Start	End	
Item	DWR UCIP Field Study			38.662976 °	38.662976 °	
				-121.456464 °	-121.456464 °	
DWR ID						
Comment Code						
Inspector Comment						
FS_ID:31310						
DS_ID:24823						
EP_NO: N/A						
Repair Type: Non-Urgent						
Crossing Status: Found						
UCIP Comments: no permit found--owner? (unauthorized?)						
FIELD_STRUCT_DESC: 24-inch pipe through the levee at unknown depth. Concrete box located on waterside (WS) shoulder. Concrete wall located on waterside (WS) and landside (LS). Siphon breaker inside concrete service box located on WS shoulder. No permit found.						
FS Date: 12/20/2013

View of levee crown at crossing.

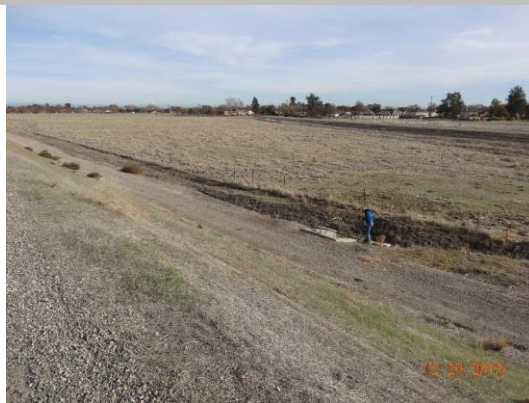
Photo 3 of 3 : UCIP_SP_2017_31310_57343.jpg

LM Start	0.08	Rating **	M	Issue No.	6 (cont)
LM End	0.08	Issue Type +	En	Location *	LS

View of landward side.

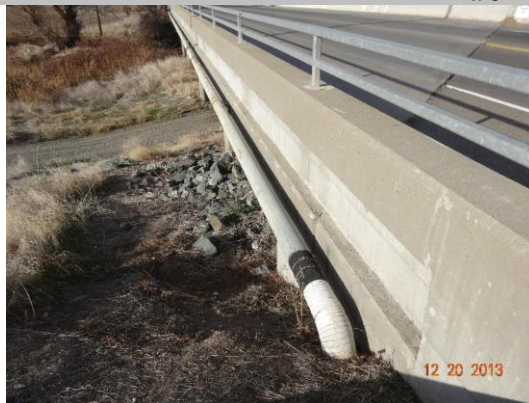
Photo 1 of 1 : UCIP_SP_2017_31311_57346.jpg

LM Start	0.48	Rating **	M	Issue No.	7
LM End	0.48	Issue Type +	En	Location *	LS
Category	Supplemental			GPS Latitude/Longitude	
				Start	End
Item	DWR UCIP Field Study			38.666585 °	38.666585 °
				-121.451009 °	-121.451009 °
DWR ID					
Comment Code					
Inspector Comment					
FS_ID:31311 DS_ID:24824 EP_NO: N/A Repair Type: Non-Urgent Crossing Status: Found UCIP Comments: owner? permit? (unauthorized?) FIELD_STRUCT_DESC: 6 inch conduit through levee at unknown depth. Conduit extends across the channel, attached to bridge. FS Date: 12/20/2013

Crossing visible on waterward side.

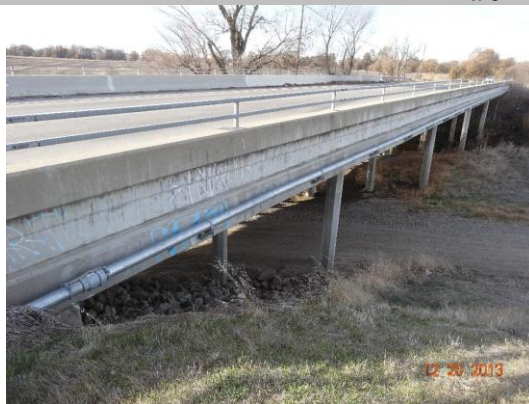
Photo 1 of 1 : UCIP_SP_2017_31312_57347.jpg

LM Start	0.49	Rating **	M	Issue No.	8
LM End	0.49	Issue Type +	En	Location *	LS
Category	Supplemental			GPS Latitude/Longitude	
				Start	End
Item	DWR UCIP Field Study			38.666745 °	38.666745 °
				-121.450918 °	-121.450918 °
DWR ID					
Comment Code					
Inspector Comment					
FS_ID:31312 DS_ID:24825 EP_NO: N/A Repair Type: Non-Urgent Crossing Status: Found UCIP Comments: owner? permit? (unauthorized?) FIELD_STRUCT_DESC: 4 inch conduit through levee at unknown depth. Conduit extends across the channel, attached to bridge. FS Date: 12/20/2013

Conduit attached to the upstream face of Rio Linda Blvd Bridge.

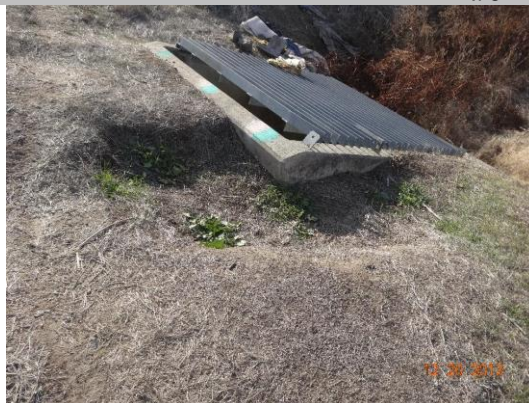
Photo 3 of 3 : UCIP_SP_2017_31313_57351.jpg

LM Start	0.52	Rating **	M	Issue No.	9 (cont)	
LM End	0.52	Issue Type +	En	Location *	LS	
Category	Supplemental			GPS Latitude/Longitude		
				Start	End	
Item	DWR UCIP Field Study			38.667108 °	38.667108 °	
				-121.450827 °	-121.450827 °	
DWR ID						
Comment Code						
Inspector Comment						
FS_ID:31313						
DS_ID:24826						
EP_NO: N/A						
Repair Type: Non-Urgent						
Crossing Status: Found						
UCIP Comments: owner? permit? (unauthorized?)						
FIELD_STRUCT_DESC: 24-inch (estimate only field verify) storm drain pipe through levee at an unknow depth. Concrete headwalls with debris screens located on waterside (WS) and landside (LS). Concrete box with protective posts located on WS shoulder. No permit found.						
FS Date: 12/20/2013

Concrete headwall located on waterward side--depression found on wall edge.

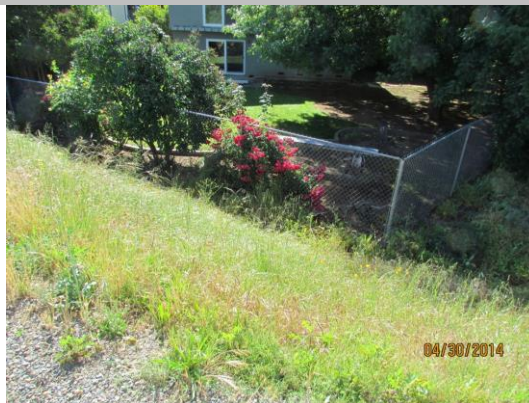
Photo 1 of 1 : SP_2017_NA0001_438_2_20170313_00002.jpg

LM Start	0.08	Rating **	M	Issue No.	2
LM End	0.08	Issue Type +	En	Location *	LS
Category	Earthen Levee			GPS Latitude/Longitude	
				Start	End
Item	Vegetation			38.571036 °	38.571036 °
				-121.353441 °	-121.353441 °
DWR ID	DWR_NA0001_12_s_2014_2				
Comment Code					
V6 : Landscaping					
Inspector Comment

View of the landscaping at the landside levee toe.

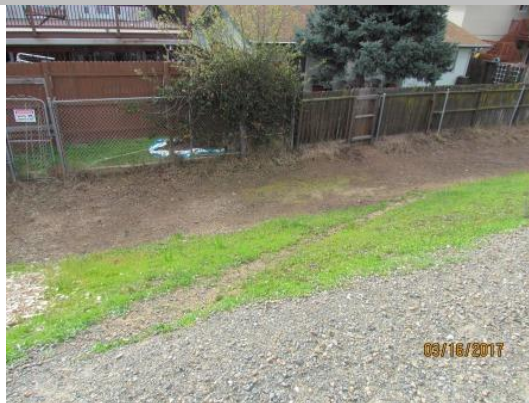
Photo 1 of 1 : SP_2017_NA0001_438_8_20170406_00014.jpg

LM Start	0.22	Rating **	A/W	Issue No.	8
LM End	0.22	Issue Type +	Ma	Location *	LS
Category	Earthen Levee			GPS Latitude/Longitude	
				Start	End
Item	Slope Stability			38.572265 °	38.572265 °
				-121.351267 °	-121.351267 °
DWR ID	DWR_NA0001_12_s_2017_8				
Comment Code					
S2 : Repair the levee slope damaged by foot traffic and prevent access where possible.					
Inspector Comment

View of the footpath on the levee slope.

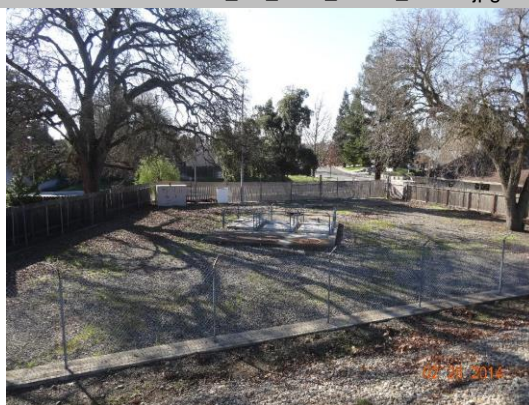
Photo 1 of 3 : UCIP_SP_2017_46995_56234.jpg

Comment Code					
Inspector Comment					
FS_ID:46995					
DS_ID:24830					
EP_NO: N/A					
Repair Type: Non-Urgent					
Crossing Status: Indicator Found					
UCIP Comments: Unable to confirm pipe size--need to contact owner to obtain additional information on crossing.					
FIELD_STRUCT_DESC: [SRCSD Facility N16 NE Siphon Outlet] 1 of 3: 48-inch reinforced concrete (RC) drainpipe through the levee at 11.0 feet below crown. Pipe crosses levee at an angle. Sacramento Regional County Sanitation District (SRCSD) Facility N16 NE Siphon Outlet located on landside (LS). Facility is fenced off. Inside facility are 3 concrete boxes with 3 manholes. (Permit No. 12144-1978, SRCSD and 12144-A-1983, SRCSD for cathodic protection)					
FS Date: 2/25/2014

Concrete vault located on landward side.

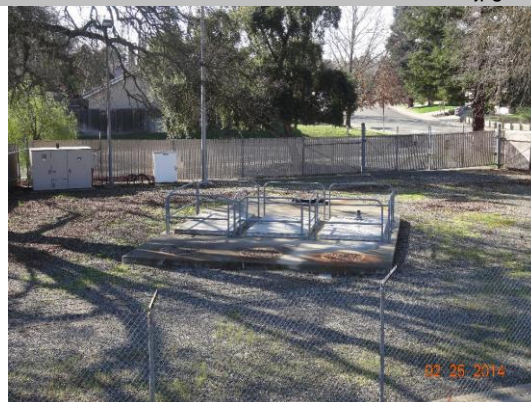
Photo 3 of 3 : UCIP_SP_2017_46995_56233.jpg

Comment Code						
Inspector Comment						
FS_ID:46995 DS_ID:24830 EP_NO: N/A Repair Type: Non-Urgent Crossing Status: Indicator Found UCIP Comments: Unable to confirm pipe size--need to contact owner to obtain additional information on crossing. FIELD_STRUCT_DESC: [SRCSD Facility N16 NE Siphon Outlet] 1 of 3: 48-inch reinforced concrete (RC) drainpipe through the levee at 11.0 feet below crown. Pipe crosses levee at an angle. Sacramento Regional County Sanitation District (SRCSD) Facility N16 NE Siphon Outlet located on landside (LS). Facility is fenced off. Inside facility are 3 concrete boxes with 3 manholes. (Permit No. 12144-1978, SRCSD and 12144-A-1983, SRCSD for cathodic protection) FS Date: 2/25/2014

Manholes located on landward side.

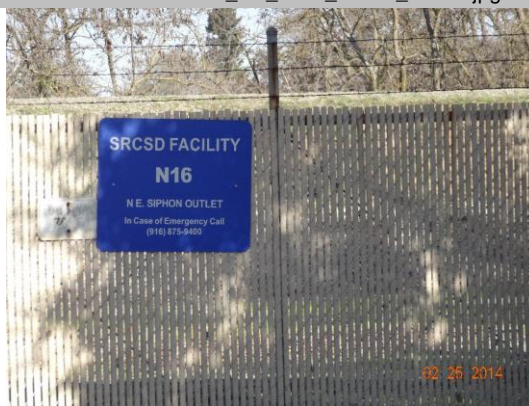
Photo 1 of 3 : UCIP_SP_2017_30540_56232.jpg

Comment Code					
Inspector Comment					
FS_ID:30540 DS_ID:24829 EP_NO: N/A Repair Type: Non-Urgent Crossing Status: Indicator Found UCIP Comments: Unable to confirm pipe size--need to contact owner to obtain additional information on crossing. FIELD_STRUCT_DESC: [SRCSD Facility N16 NE Siphon Outlet] 2 of 3: 48-inch reinforced concrete (RC) drainpipe through the levee at 11.0 feet below crown. Pipe crosses levee at an angle. Sacramento Regional County Sanitation District (SRCSD) Facility N16 NE Siphon Outlet located on landside (LS). Facility is fenced off. Inside facility are 3 concrete boxes with 3 manholes. (Permit No. 12144-1978, SRCSD and 12144-A-1983, SRCSD for cathodic protection) FS Date: 2/25/2014

SRCSD Facility N16, NE Siphon Outlet, sign visible from Mira Del Rio Drive.
